# Hume Draw Watershed Assessment

## Master Improvement Plan Report – May 31, 2024

City of Sheridan, Wyoming

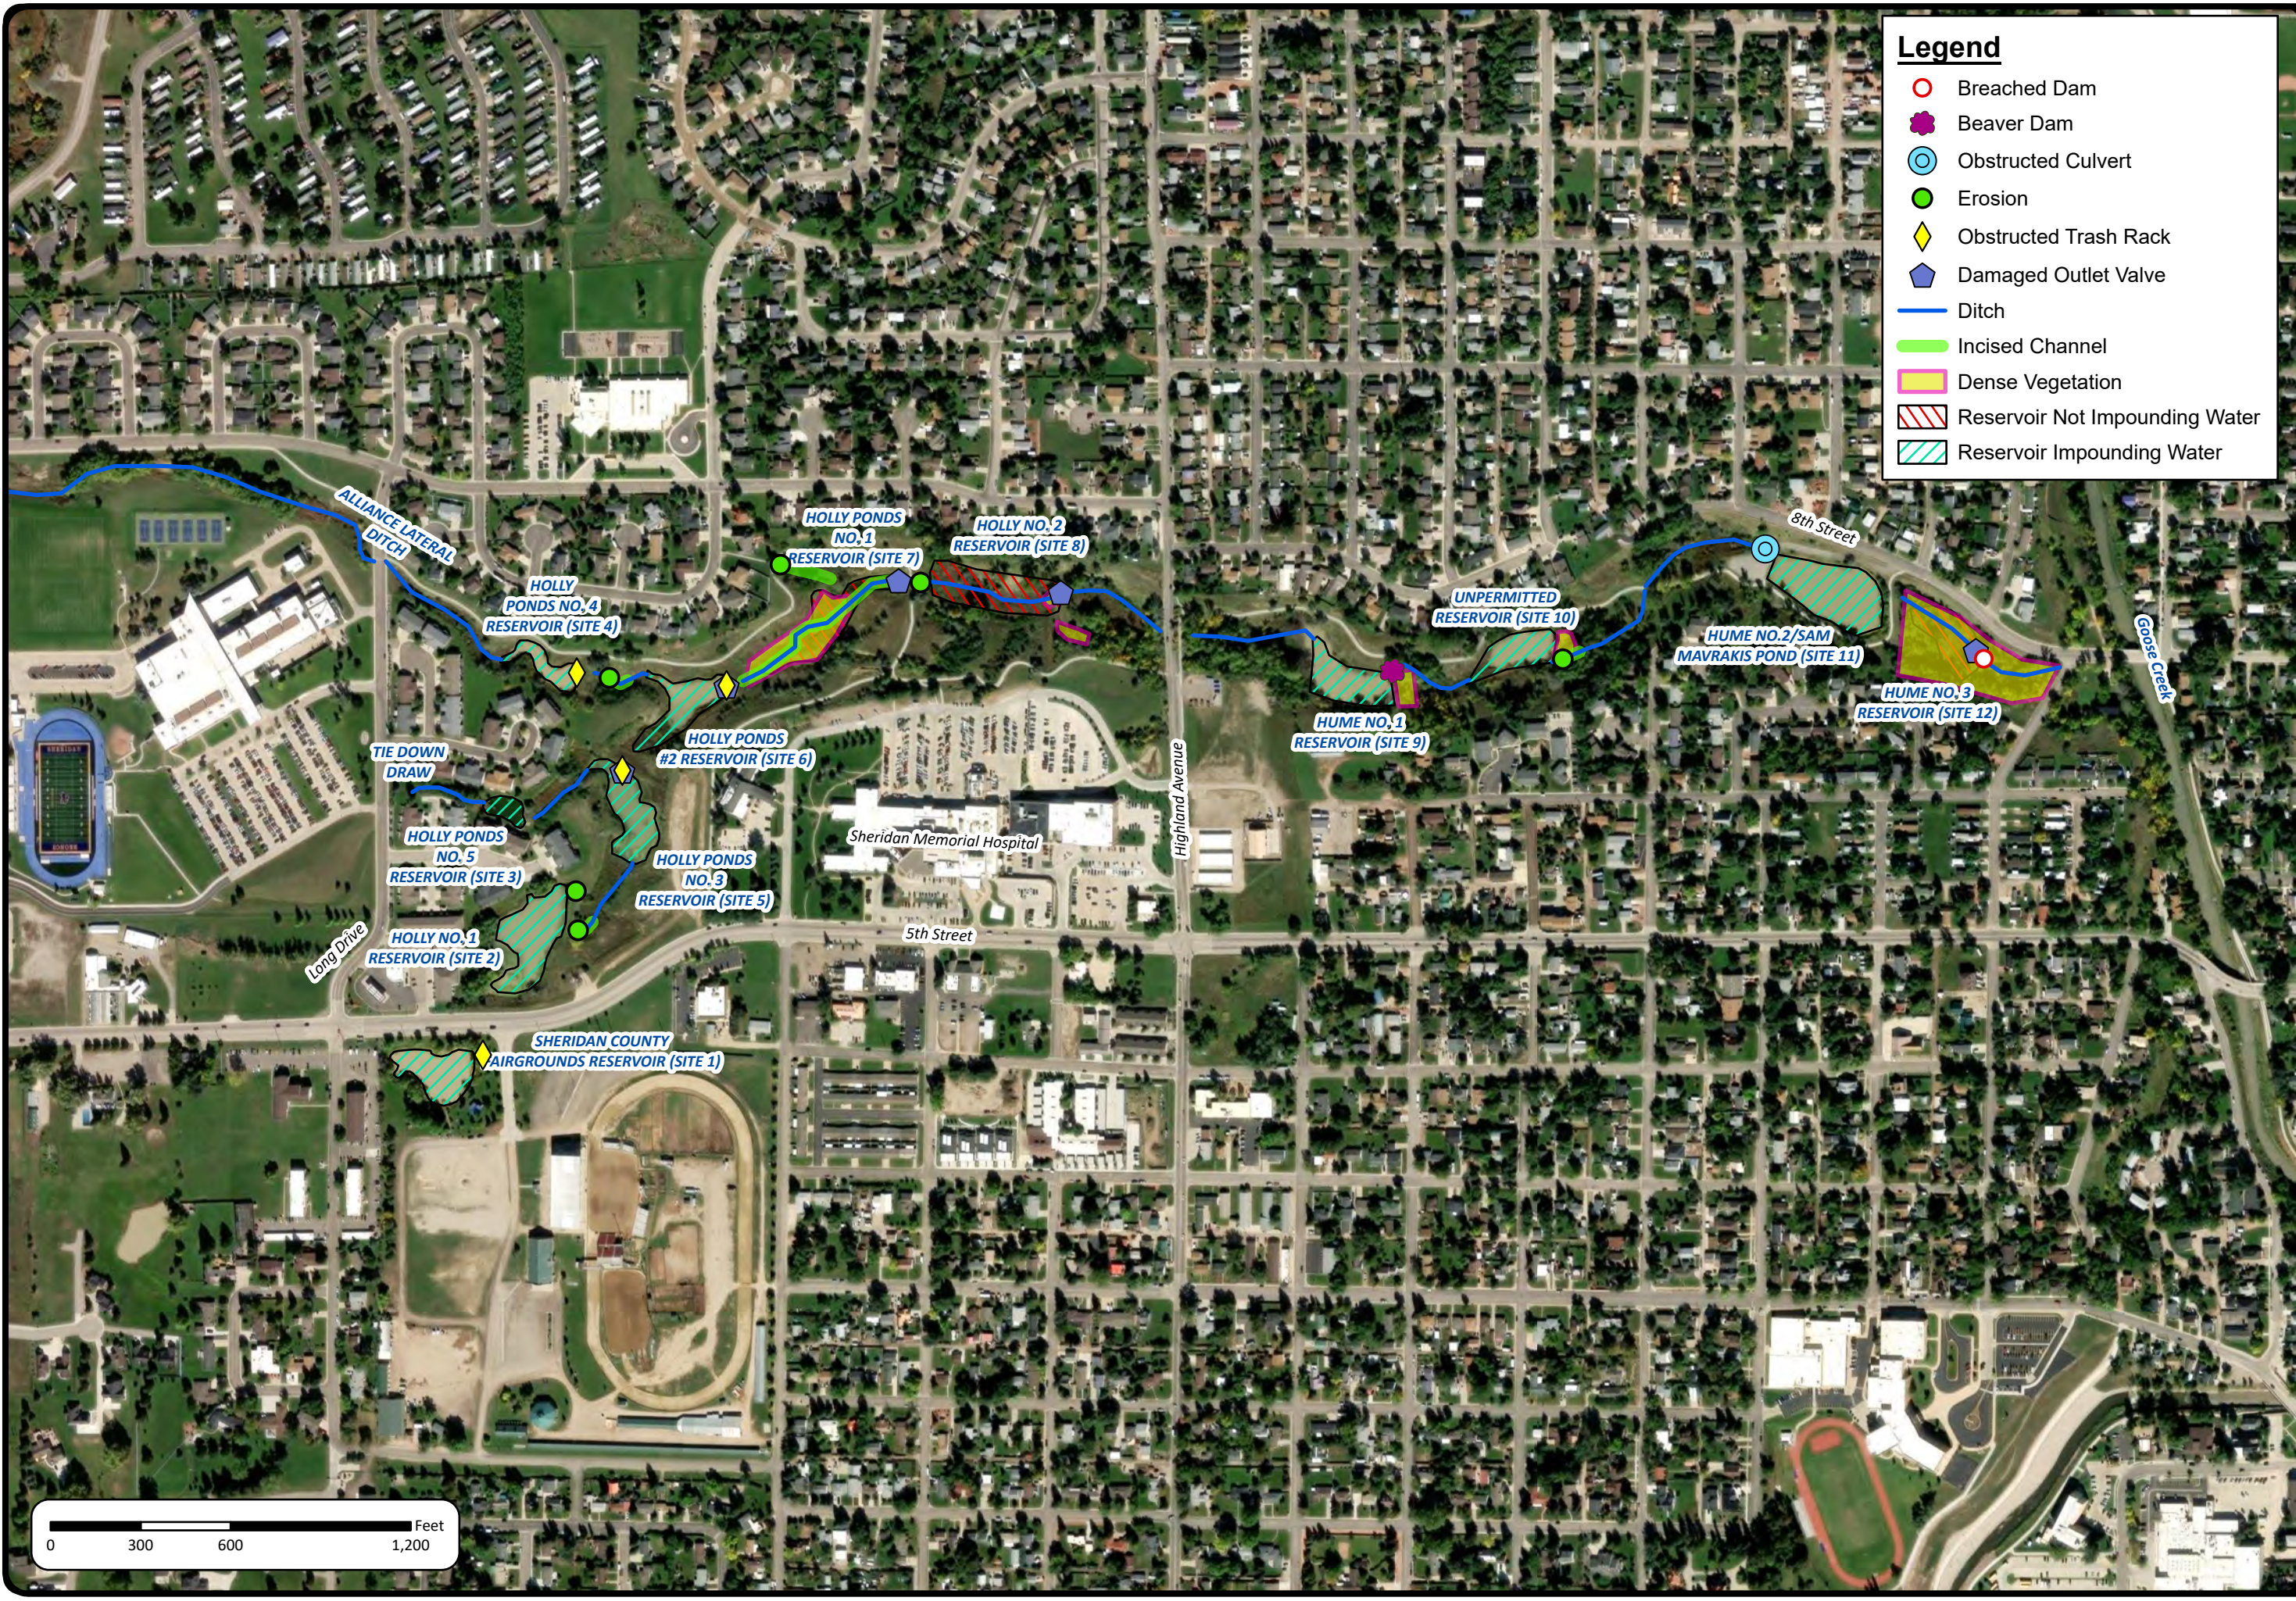
**MAINTENANCE ITEM RECOMMENDATIONS**

The assessment identified several areas of dense riparian vegetation that have choked the drainage bottom and associated ditches and are currently restricting flow (Figure 5). These areas consist primarily of willows, dogwood, and other native and non-native shrubs with robust hydrophytic ground cover. Noxious weeds seem to be lacking within these dense native shrub patches and primarily occur along the walking trails and disturbed habitats located within the dry reservoir bottoms. Recent weed control locations are identified in Figure 4 and predominately consist of cheatgrass, loosestrife, and spurge. Weed control is an ongoing maintenance item and removal of dense vegetation in areas that restrict channel flow should be considered as part of the overall vegetation management program.

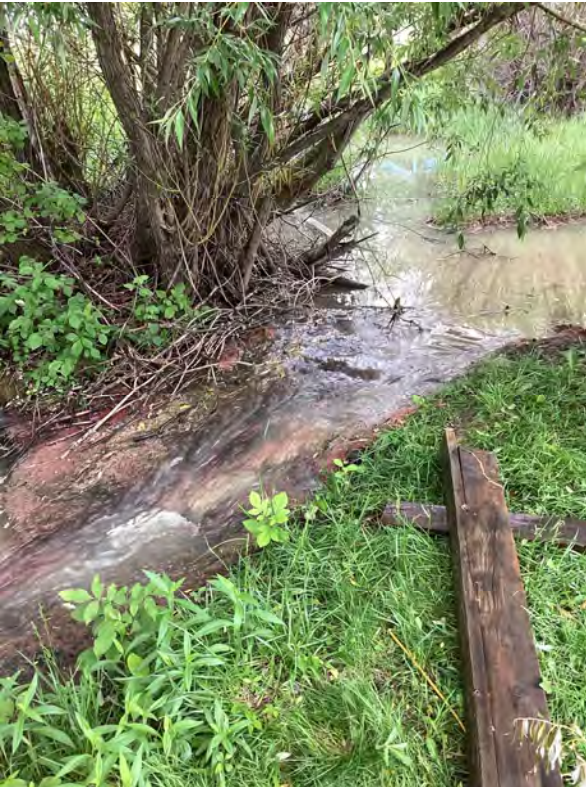
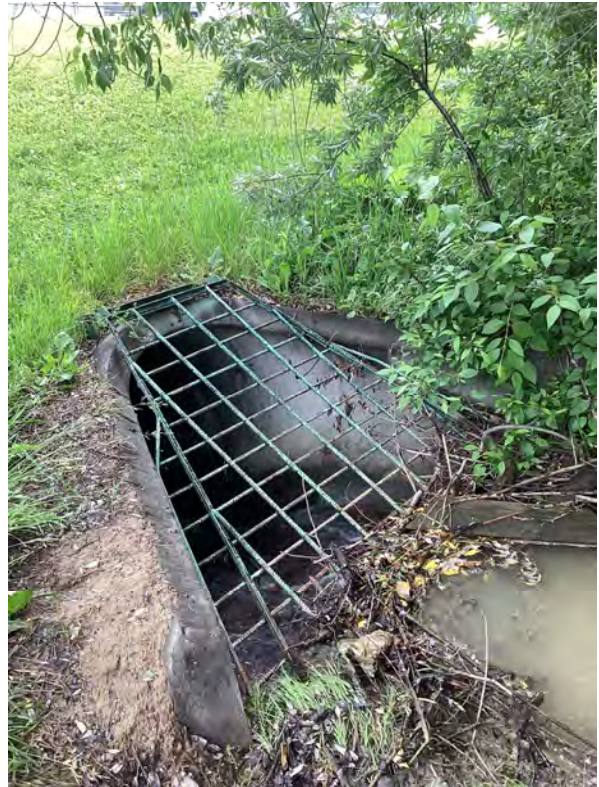
1.3 Sheridan County Fairgrounds Reservoir - Eroded Spillway (Looking Southeast)

The open channel outlet at this location should be repaired and riprapped to reduce flow velocity. Placement of suitable check dams or riprap within these sections would reduce flow velocity, prevent further erosion, and reduce the amount of sediment that is transported downstream into Holly No. 1 Reservoir.

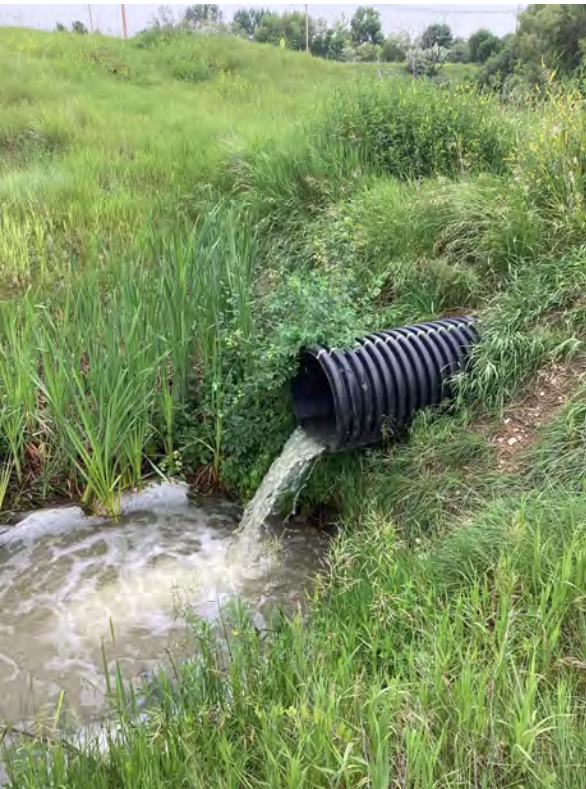
2.3 Holly No. 1 Reservoir - Reservoir Outlet (Looking Southwest)

The poorly placed and inadequately protected horizontal decant pipe at Site 2 functions as the only constructed outlet for the reservoir. It is located near the dam's south abutment and discharges onto the high, steep, and unprotected downstream abutment area. This results in deep active erosion below the outlet pipe and continues for a significant distance downstream. The existing trash rack does not adequately prevent clogging of the decant pipe, and this maintenance issue has recently resulted in highwater overtopping the crest of the dam near its north abutment. Significant deep active erosion of the downstream face of the north abutment is also evident at this location. At a minimum, an improved trash rack should be installed in front of the inlet to the horizontal decant pipe to prevent impedance and highwater from overtopping the dam. Suitable imported material should also be placed and compacted on the crest of the dam to replace material lost during overtopping. Additionally, all active erosion should be repaired, and rock armored as soon as practical to prevent potential failure of the dam.

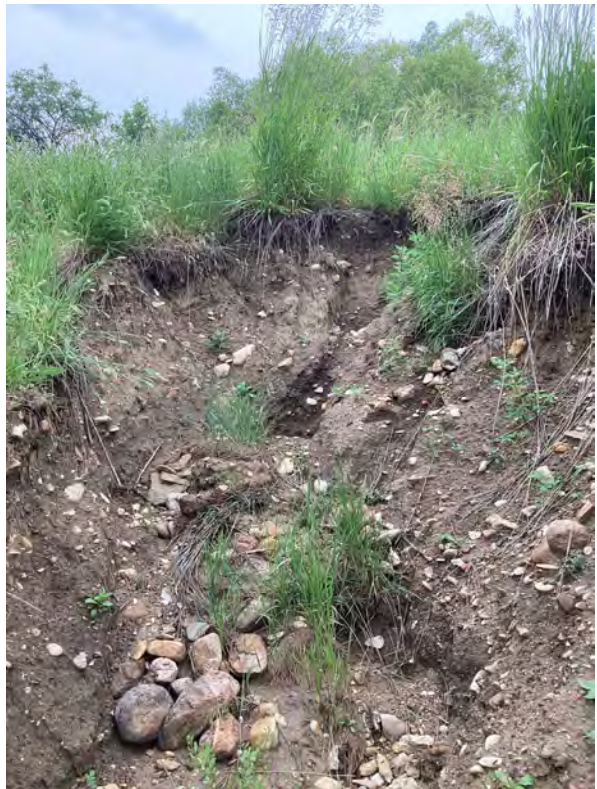
2.4 Holly No. 1 Reservoir - Erosion on North End of Dam On East Side (Looking Southwest)

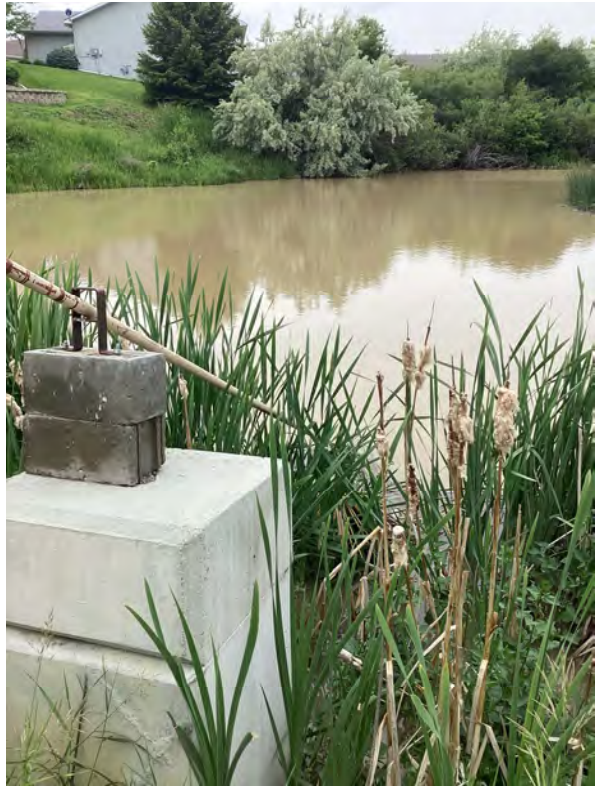
4.2 Holly Ponds No. 4 Reservoir - Outlet Structure (Looking West)

The dam and outlets at Site 4 appear to be generally in satisfactory condition. However, the large concrete blocks associated with the gate valve have settled and should be leveled to prevent deterioration. As routine maintenance, the slide gate valve should be tested, and the trash rack cleared of accumulated debris.

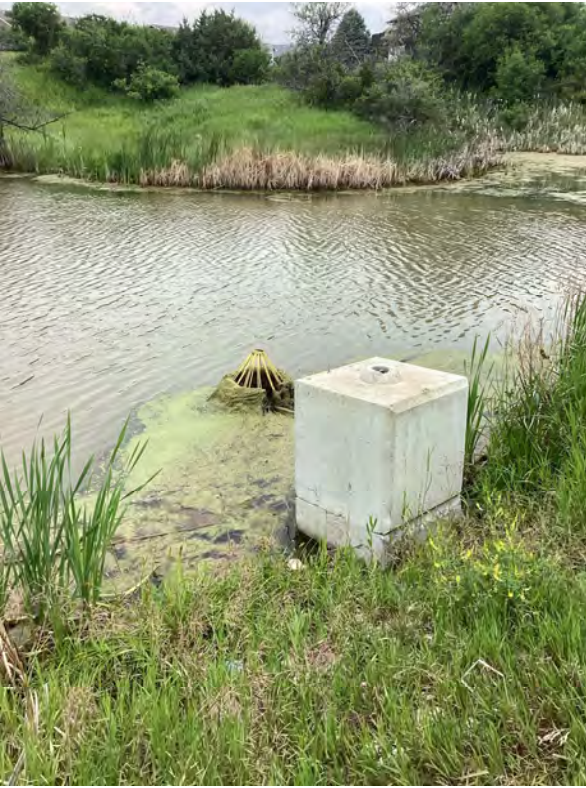
5.1 Holly Ponds No. 3 Reservoir - Outlet Structure (Looking West)

The gate valve and supporting structure at Site 5 is damaged and needs to be repaired or replaced, possibly with a different design to prevent damage from ice. The trash rack should be routinely cleared to prevent artificially high-water levels in the reservoir and subsequent damage.

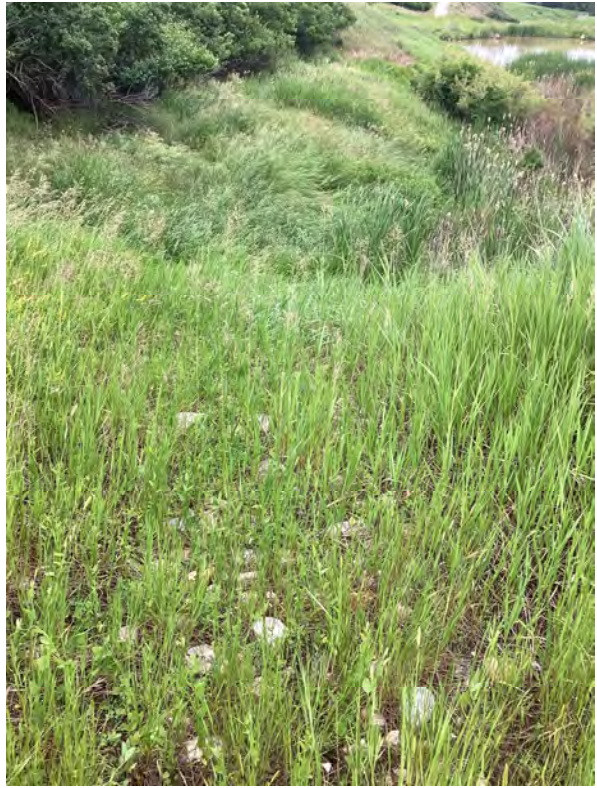
5.2 Holly Ponds No. 3 Reservoir - Emergency Spillway (Looking Northeast)

Install riprap or armor in the emergency spillway to prevent deterioration of the dam and reduce turbidity, suspended solids and sedimentation.

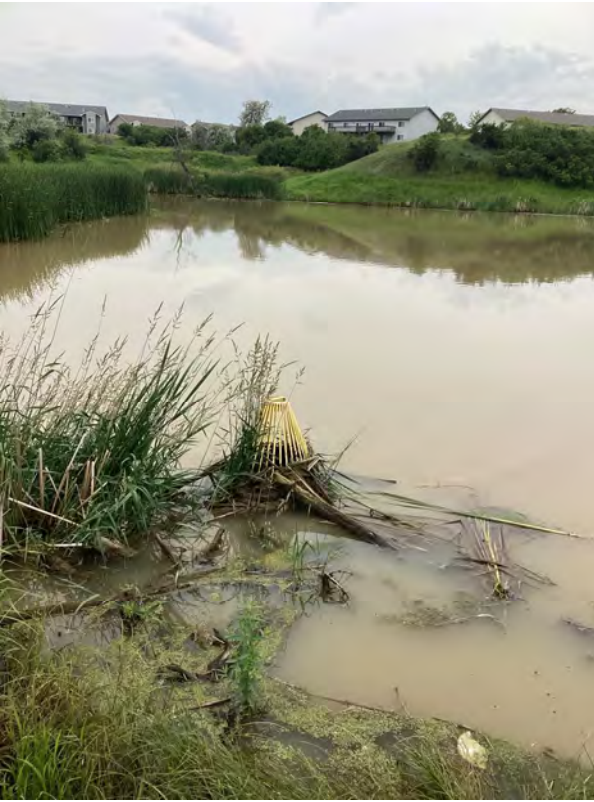
6.1 Holly Ponds #2 Reservoir - Trash Rack (Looking West)

The gate valve and supporting structure at Site 6 are damaged and need to be repaired, or possibly replaced with a different design to prevent damage from ice.

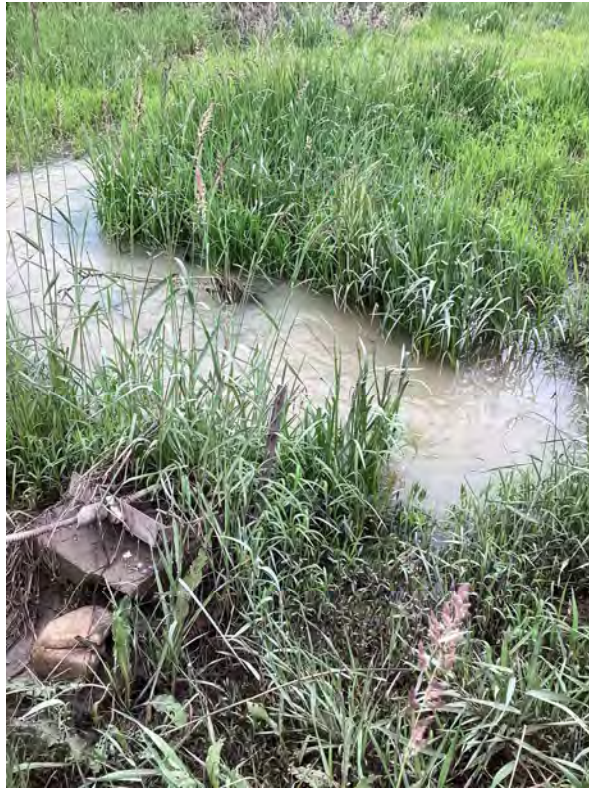
Site 7 does not currently impound water due to its damaged gate valve and there is possibly additional damage to the vertical decant which functions as a secondary outlet. Its current condition does not present a notable safety threat and multiple options for this site are included as proposed medium priority actions. One safety item was identified in the native drainage that discharges into the north side of this reservoir, near its midsection. Significant erosion is migrating farther upgradient from an existing storm drain outlet and may eventually undercut the walking path. The deep erosion extends downgradient towards the reservoir. Given the steep gradient in the drainage and observed deep erosion, measures to repair and stabilize the area with riprap should be implemented as a high priority. This effort will also contribute appreciably to reduced sediment transport and lower turbidity downstream.

7.3 Holly Ponds No. 1 Reservoir - Gate Valve (Looking Southwest)

- Option A) Repair or replace existing slide gate to restore hydrologic function and maintain permit compliance.
- Option B) Abandon the reservoir and transfer the permitted water rights downstream to Site 10, the unpermitted reservoir. Remove slide gate, breach and reclaim dam, riprap outlet, and allow channel and banks to reestablish.
- Option C) Abandon the reservoir and transfer the permitted water rights downstream to Site 11 and enlarge Sam Mavrakis Pond. Remove slide gate, breach and reclaim dam, riprap outlet, and allow channel and banks to reestablish.
- Option D) Abandon Site 7 and remove slide gate, breach and reclaim dam, riprap outlet, and allow channel and banks to reestablish.

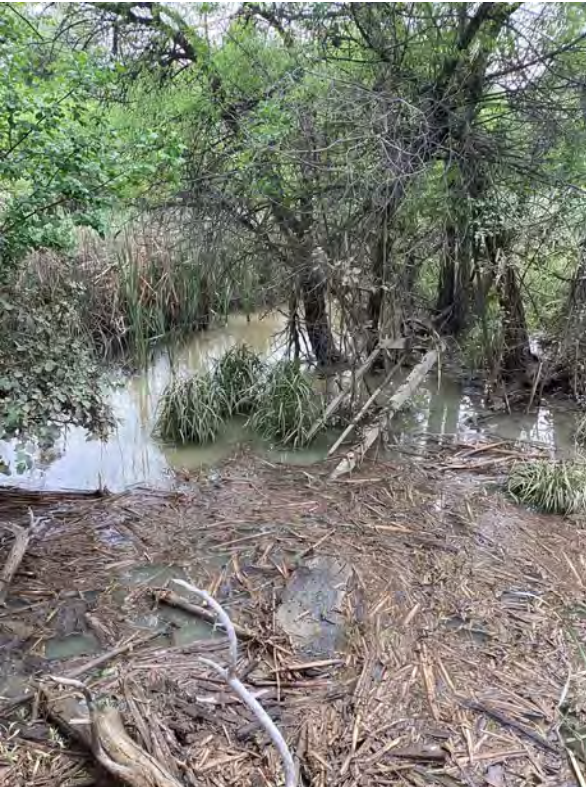
8.3 Holly No. 2 Reservoir - Gate Valve (Looking Southwest)

To ensure long-term function, the gate valve at Site 8 should be replaced, possibly with a different design to prevent damage from ice. The woody vegetation growing on the dam should be removed. This may result in the need for significant

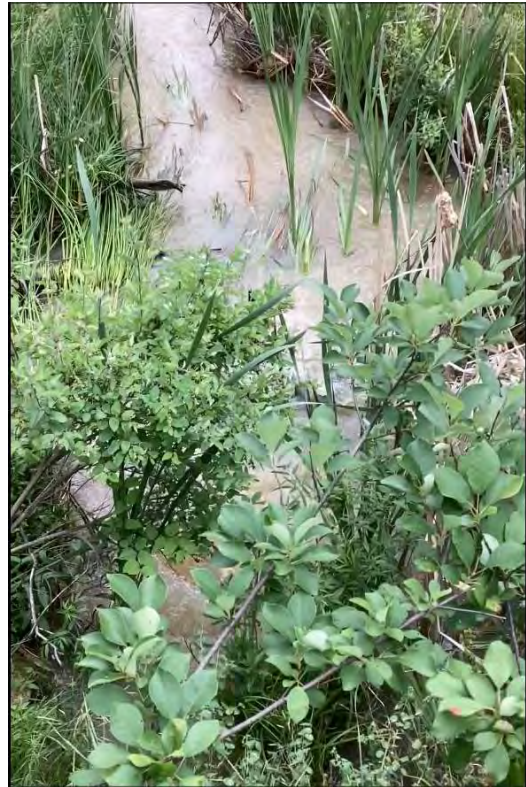
Holly No. 2 Reservoir is located east of Site 7. Site 8 receives discharge from Site 7, a stormwater outlet located north of the southern end on the reservoir, and runoff from Sheridan Memorial Hospital parking lot (Figure 3). The reservoir is near the pathway, but it is not easily accessed and there are no improvements for public use. The slide gate outlet is significantly damaged and allows for a very small amount of water to be impounded. Trees and shrubs are present on the dam and in the emergency spillway. A large amount of wood debris was observed around the damaged outlet.

8.4 Holly No. 2 Reservoir - Outlet (Looking East)

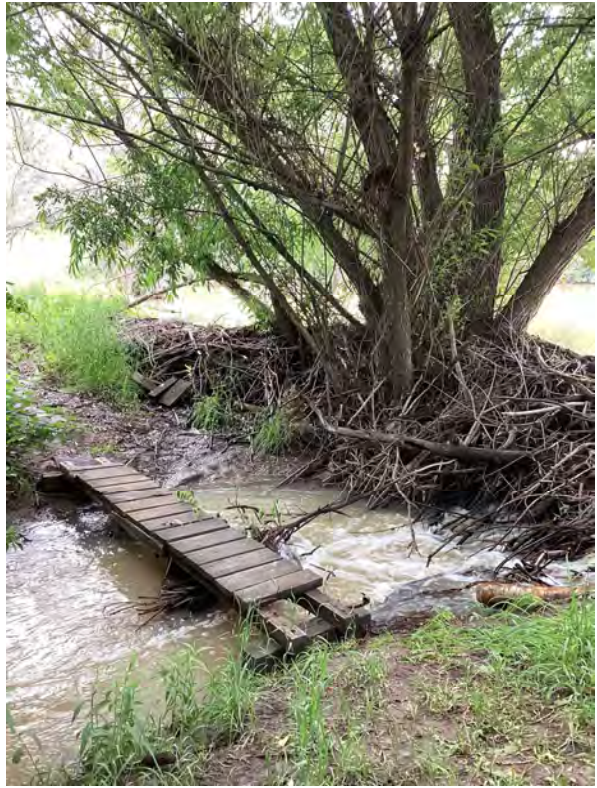
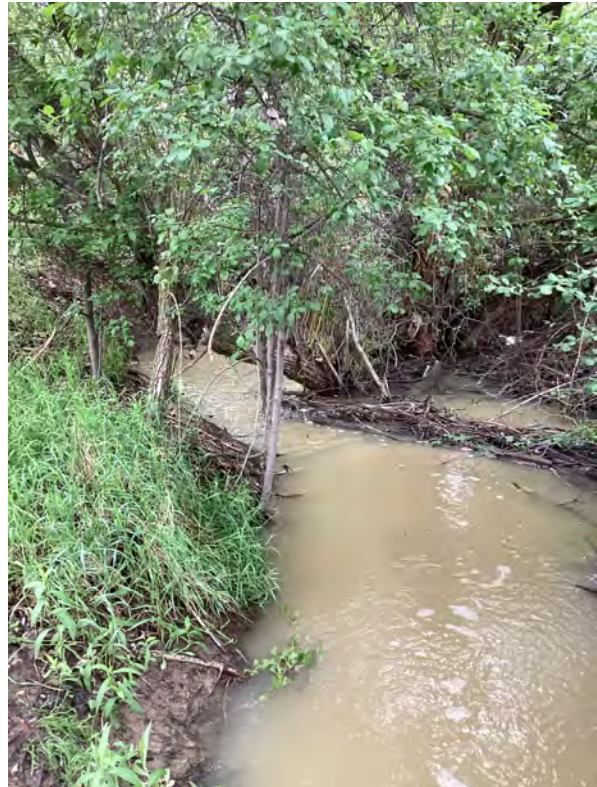
Hume No. 1 Reservoir is located east of Site 8. It receives discharge from Site 8 and two stormwater outlets (Figure 3). The reservoir can be accessed from the north during dry conditions. Beaver have constructed a dam across the spillway and along the crest of the dam. As a result, water levels in the reservoir were elevated approximately 1½ feet. The elevated water levels inundated the gate valve and operating mechanism and reduced much of the designed freeboard along the dam. At the time of the inspection, much of the discharge was routed through the partially obstructed spillway. Trees and brush are present on the dam and in the emergency spillway, and within the downstream channel. Additionally, there is significant accumulation of deadfall and wood debris in the spillway and downstream channel that increases turbulent flow, resulting in significant erosion, high turbidity, and increased sediment transport.

9.2 Hume No. 1 Reservoir - Emergency Spillway  
(Looking South)

9.4 Hume No. 1 Reservoir - Emergency Spillway  
(Looking East)

Beaver activity has created unsafe conditions and artificially elevated water levels and efforts should be implemented for removal of the beaver dams from the crest of the dam and along the emergency spillway. Animal removal is a sensitive topic; therefore, this may be a long-term frequently occurring maintenance item. Beavers are a catalyst for creating ecologically diverse habitats and in a more natural setting would help improve overall ecological function within the drainage; however, with the heavily engineered nature of this drainage and desire to increase surface flows through the system, beaver activity may hinder overall management goals. After beaver dam removal and water levels subside, an inspection of the existing sliding gate valve outlet is needed to determine options for repair or replacement. Removal of woody plants and debris is needed to stabilize the dam and outlets. Placement of riprap will reduce flow velocity and stabilize erosion in the spillway and downstream channel and will reduce turbidity and sediment transport farther downstream.

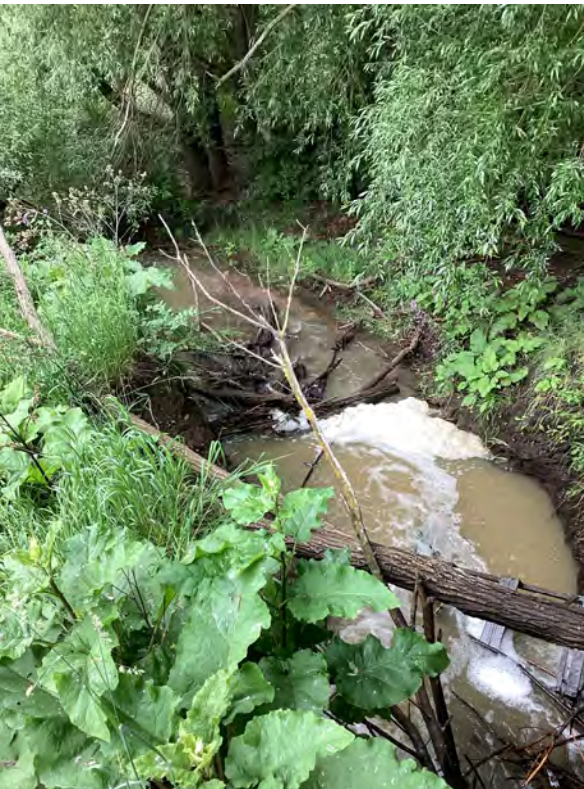
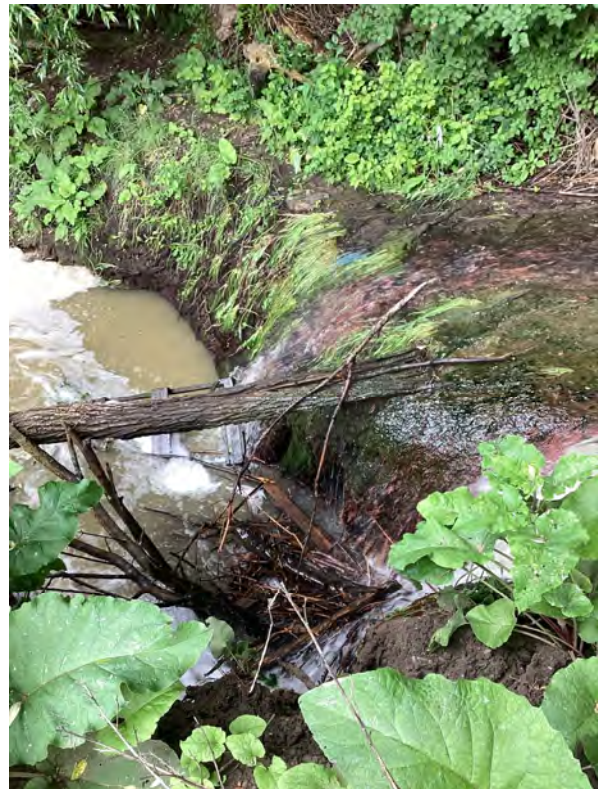
10.3 Unpermitted Reservoir - Emergency Spillway  
Erosion (Looking South)

10.4 Unpermitted Reservoir - Emergency Spillway  
Erosion (Looking South)

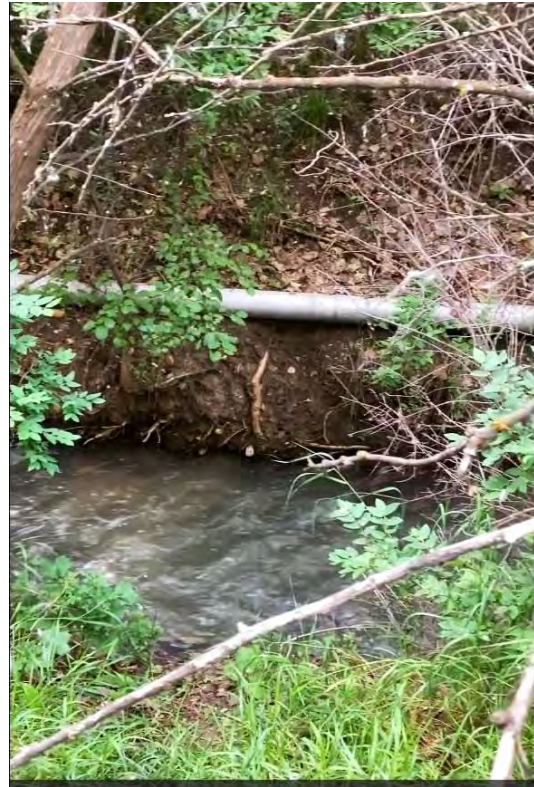
The condition of the dam and outlet prevents impoundment of water; therefore, a bathymetric survey was not performed. The original permitted capacity of the reservoir is 3.2 acre-feet.

12.4 Hume No. 3 Reservoir - Dam Breach (Looking South)

- Option A) Replace existing non-functional slide gate, repair breached dam, remove woody vegetation from dam and reservoir bottom. Extend walking path for access from Site 12.
